General

SRS Airbag, Safety Belts and Bunk Restraints

This publication contains service information about the safety belts, bunk restraints and supplemental restraint system. It is intended for use by service technicians who have attended and received certification in the Volvo Truck Supplemental Restraint System class (88A). The service procedures and fault tracing instructions may only be carried out by certified technicians. Volvo Trucks North America, Inc. will not assume any liability whatsoever for damage incurred, either damage to materials or personal injury, which may result if the service procedures are not followed or if the work is carried out by non-certified personnel.

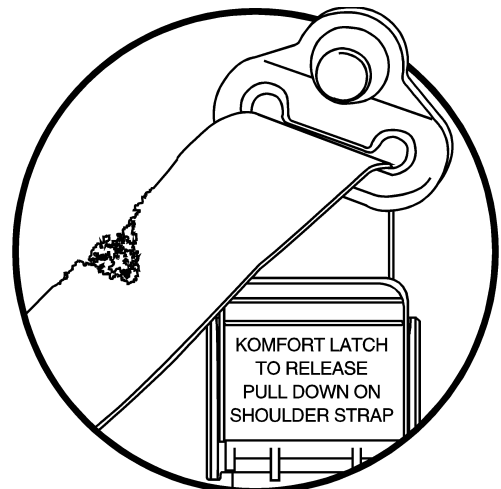
W8001405

The D-loop web guide is an area where almost constant movement of the safety belt webbing occurs because of the relative movement between the seat and the cab. Because of this constant movement this is an area where wear will often occur. The webbing must be closely examined to determine if there are any cuts, frays or extreme wear in the webbing. Cuts, frays or excessive wear indicate the need for replacement of the safety belt system.
